Feather River Coordinated Resource Management Watershed Monitoring Program

2011 Report

Prepared by Plumas Corporation
Quincy, CA
April 2012

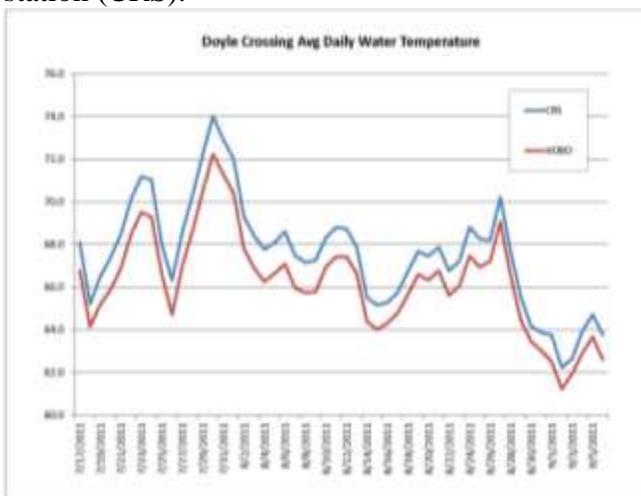
Figure 13. Daily Average Water Temperature at Doyle Crossing

Last Chance Creek at Doyle Crossing and Lights Creek are consistently the most temperature impaired channels, followed by Wolf Creek. This temperature impairment of Last Chance, Wolf, and Lights creeks may be from the diminishment of groundwater recharge and release function of the watershed above these stations. Maximum daily water temperature at Doyle Crossing continues to decline, but the locally high temperature readings at Doyle Crossing on Last Chance Creek is thought to be attributed to enhanced solar radiation from water sheeting over bedrock and a 400-foot long unshaded pool above the recording station. During May-October 2011 a HOBO temperature logger was placed upstream of this pool to record water temperature previous to flowing through the unshaded section of Last Chance Creek. The temperature recorded by the HOBO logger was on average 1.3 degrees Fahrenheit cooler than the temperature recorded by the continuous recording station (CRS).

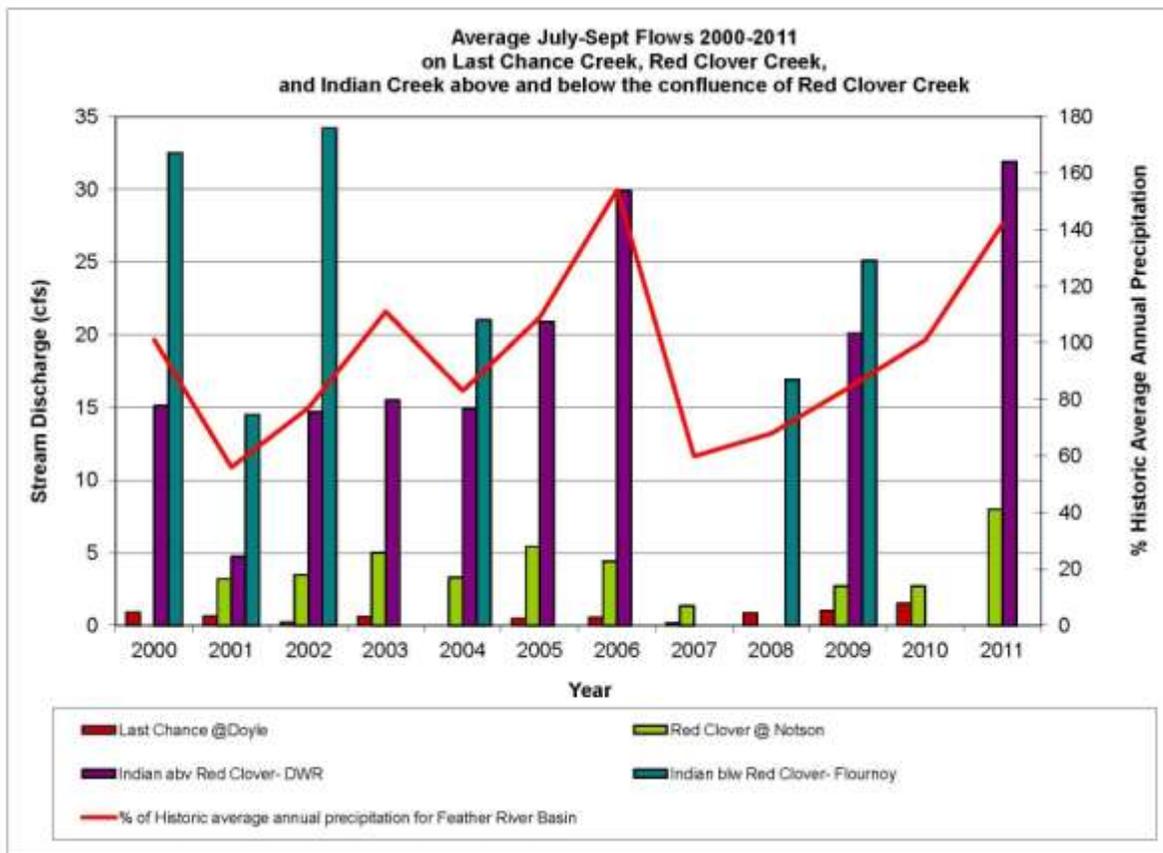
Figure 14. Average Summer Stream Flow from 2000-2011 on Last Chance Creek, Red Clover Creek, and Indian Creek above and below the confluence of Red Clover Creek

Figure 14 displays the average summer (July 1- Sept 30) stream flows on Last Chance, Red Clover, and Indian creeks. Precipitation in 2006 is relatively comparable to 2011. Figure 15 displays 2011 WY average summer stream flows for all continuous recording stations.

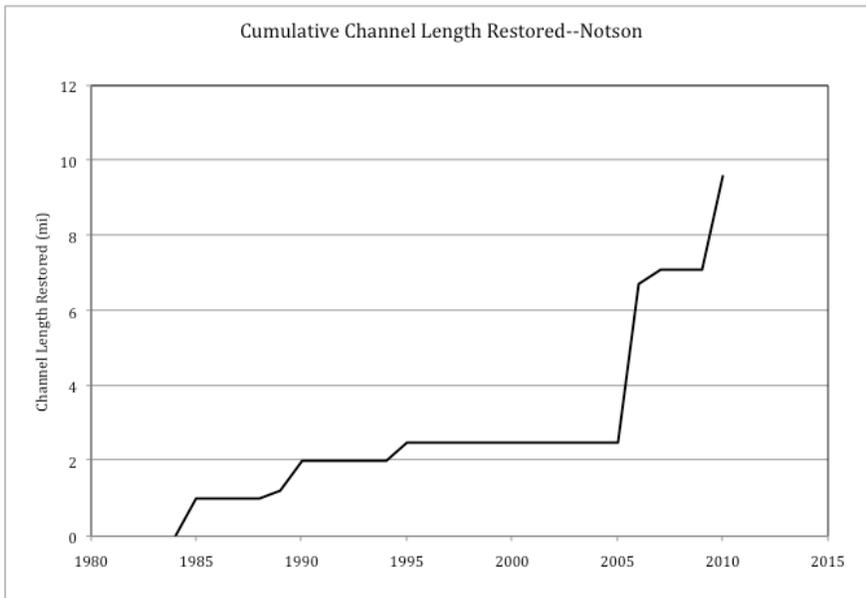
Figure 17: Length of restored channel over time on Red Clover Creek above Notson Bridge

Figures 17 and 19 show length of channel restored over time on Red Clover Creek and Last Chance Creek respectively. These charts, from Ken Cawley's Statistical Analysis of Feather River CRM stream flow data, are included to see if there is any trend or pattern related to stream restoration miles.

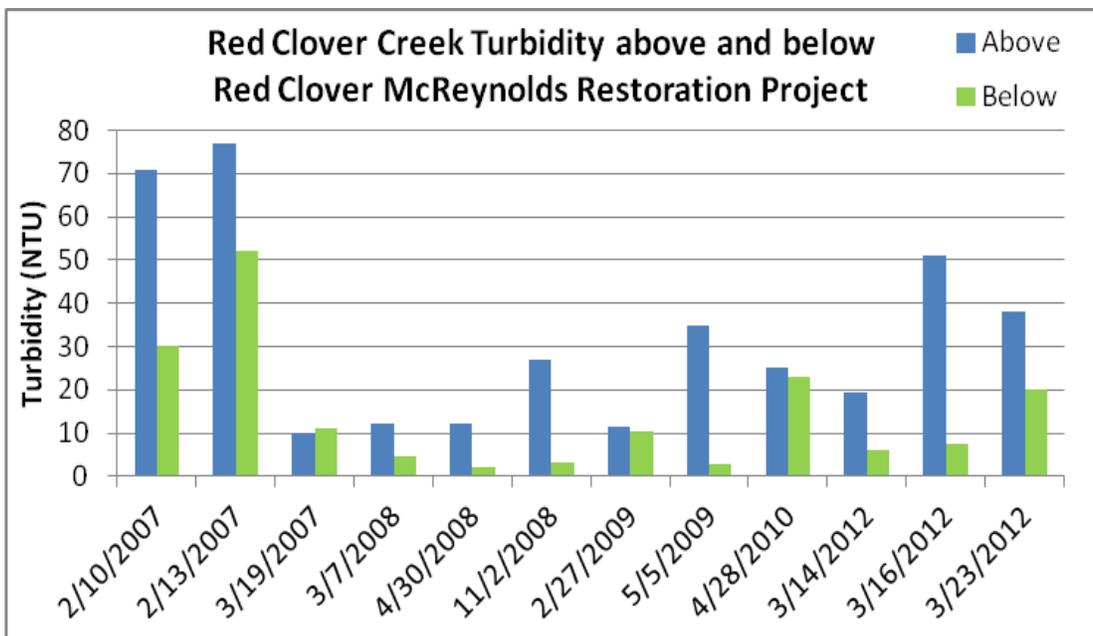
Figure 30: Red Clover Creek turbidity during storm events from 2007-2012

The FRCRM was established to address widespread erosion, sedimentation and associated channel degradation in the Feather River watershed. The FRCRM approach to erosion control has evolved from installing check dams and bank protection to restoring meadow floodplain function. Turbidity is a surrogate for sedimentation, measuring relative changes of fine sediment in the water. Turbidity is measured in Nephelometric Turbidity Units (NTUs). Fine sediments can be the most damaging to aquatic habitats and, in large quantities, can fill reservoirs. The FRCRM generally measures turbidity above and below a restoration project to determine if the project is capturing sediment on the floodplain and reducing the amount of sediment that flows downstream. Figure 30 shows turbidity above and below Red Clover McReynolds Restoration Project during storm events from 2007-2012. On the Red Clover McReynolds project average turbidity is 50% less below the restoration project than above.

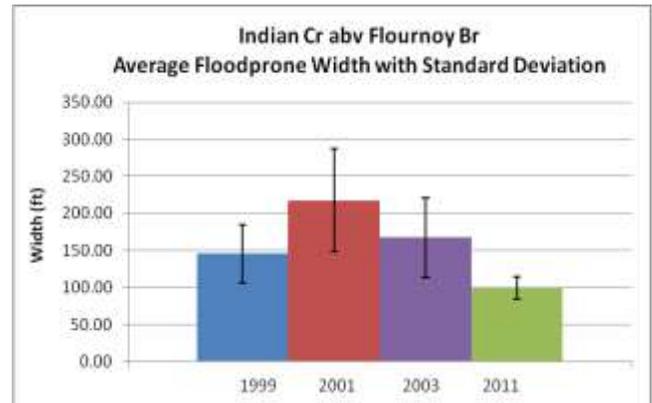
Figure 33. Indian Cr above Flourney Br Floodprone Width

Indian Creek above Flourney Bridge (below the confluence of Red Clover Creek) appears to be relatively stable. There has been an increase in bank stability due to the increased vegetation (see below photos). There has been a decrease in tolerant macroinvertebrate taxa. The riffles in the reach have moved downstream over the past eight years, and the pool depth is deeper. Floodprone width decreased in 2011, but Figure 33 shows there is no significant difference between the floodprone widths from 1999, 2003, or 2011. The difference in width is possibly due to errors in interpreting bankfull width, or because of riffle location shifts.

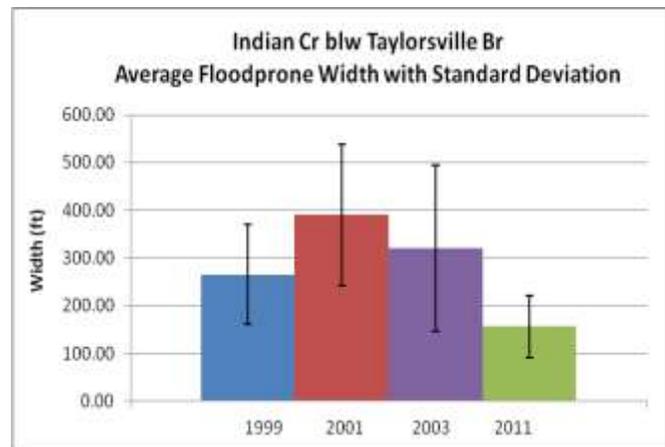
Figure 34. Indian Cr below Taylorsville Br floodprone width

Like Indian Creek above Flournoy Bridge, Indian Creek below Taylorsville Bridge has become more stable since 1999, and since the 1997 flood. This is due to the amount of vegetation present on the stream banks. The Taylorsville monitoring reach has also shown a decrease in tolerant macroinvertebrate taxa. Some of the habitat types have changed throughout the reach due to a beaver dam downstream of cross-section two. This caused cross-section two to be in a pool/backwater area. We did not move this cross-section. Floodprone width through the reach has narrowed since 1999-2003, but Figure 34 displays no statistically significant difference in the floodprone widths from 1999, 2003, or 2011. The difference is probably due to problems identifying bankfull width, or the shift in riffle crest location.

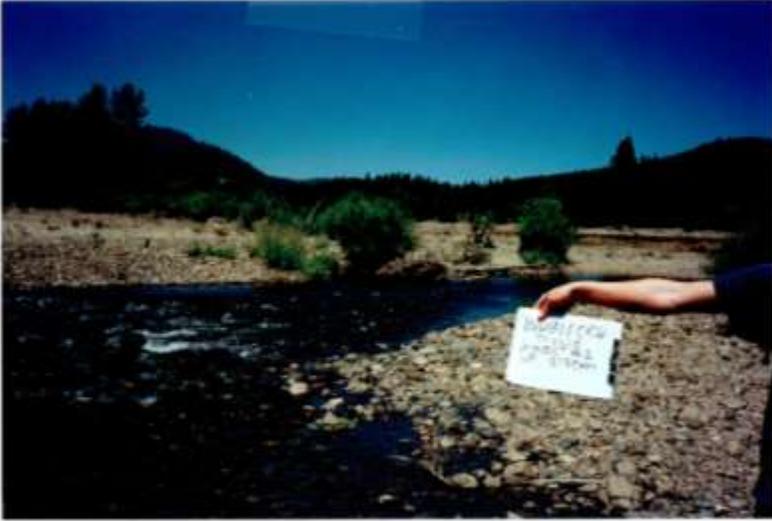
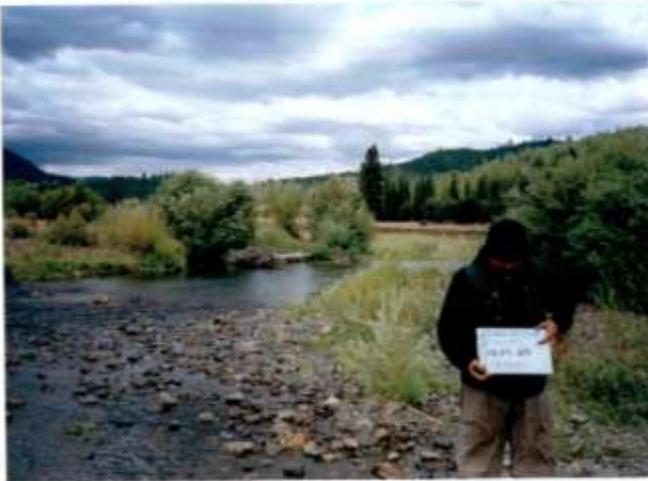
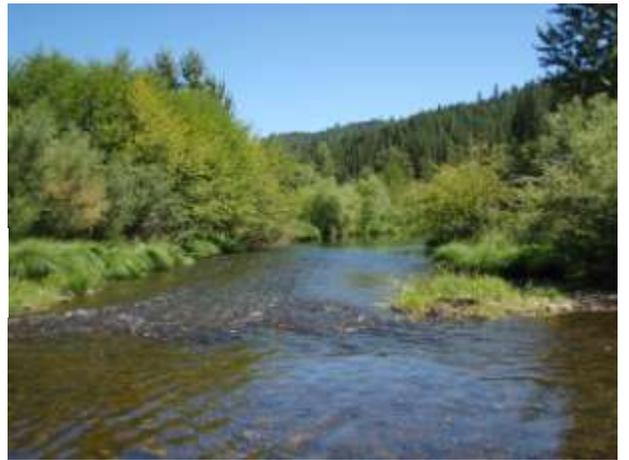
X-Sec 1, Downstream, 1999

X-Sec 1, Downstream, 2001

X-Sec 1, Downstream, 2011

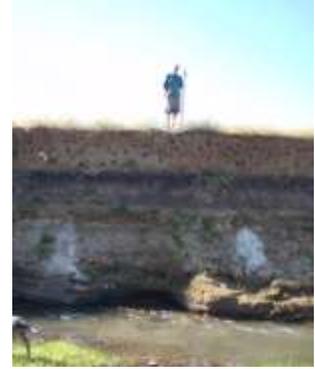
X-Sec 1 looking downstream

Lights Creek channel cross-sections have shown a decrease in cross-sectional area over the past twelve years. Residual pool depths have gotten deeper, as well as sediment size getting smaller. The percent tolerant macroinvertebrate species has increased notably since 1999. Lights Creek above Deadfall Lane Br. continues to be an unstable site.

X-Sec 2 left bank

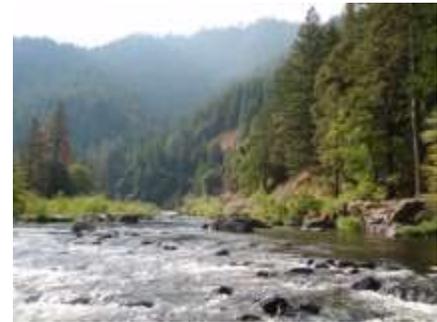
X-Sec 1 looking upstream

The East Branch North Fork Feather River (EBNFFR) monitoring reach is showed a significant decrease in bankfull width and mean bankfull depth in 2011. This decrease signifies a significant decrease in cross-sectional area. Residual pool depth has increased, as well as the percent tolerant macroinvertebrate taxa. Substrate size has decreased over the past ten years.

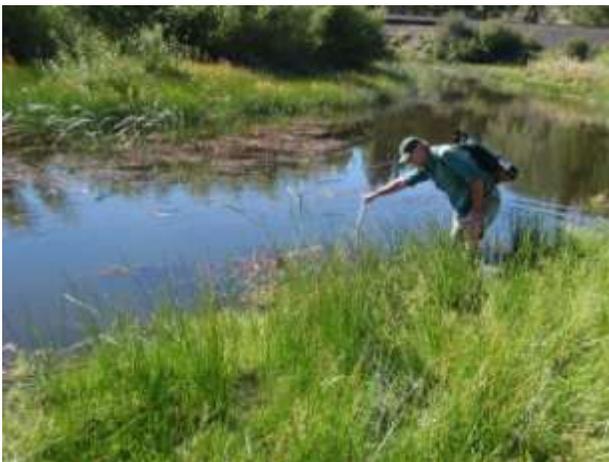
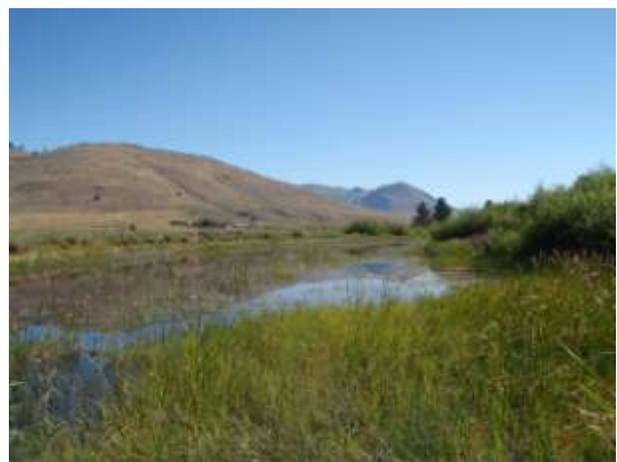
The Middle Fork Feather River has been a problematic site since 1999. In the past there has been a lack of continuous surface water through the monitoring reach during the summer months. In 2011 water from a downstream beaver dam backed up through the monitoring reach. The influence from the beaver dam rendered the reach incompatible with the Stream Condition Inventory protocol. All the riffles in the reach were flooded with minimum depths of two and a half to three feet deep. The below photos display the three cross-sections in the monitoring reach and the lack of fast water in the reach.

X-Sec 1 and downstream

X-Sec 2

X-Sec 3 and upstream
